TECHNICAL BULLETIN BONNEVILLE RACE TIRES

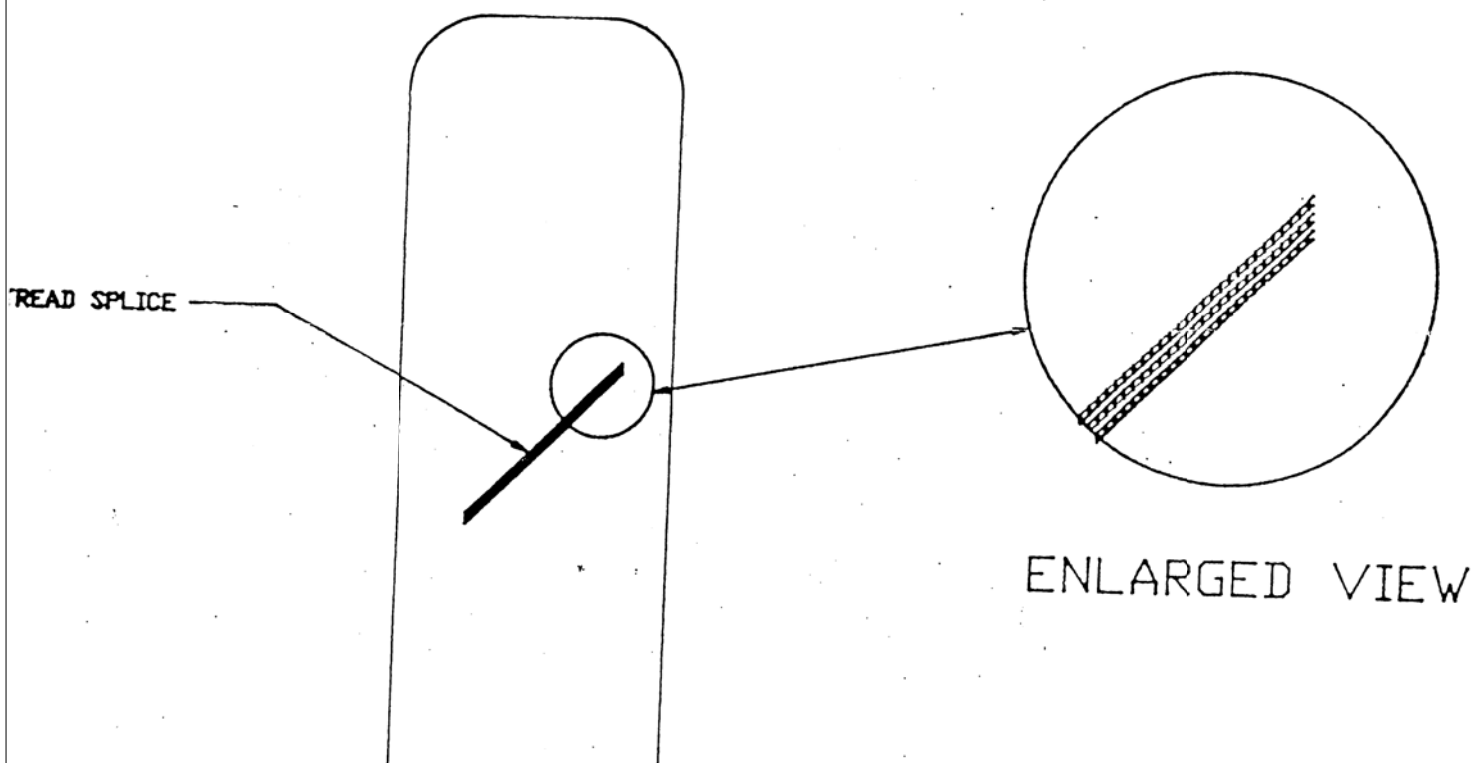
There has been some concern brought up by Bonneville racers regarding our high speed tires, which needs to be addressed. It has been noticed that after our Bonneville tires have been run, a few cords start to appear diagonally across the tread surface at approximately a 45 degree angle. This is NOT a defect in the tire, but is the point where the plies overlap and are spliced together, and due to the thin protective coating on the tread surface, this splice will appear in time. However, if the protective coating is worn off in places other than the tread splice, then the tire is beyond useful life and needs to be replaced.

WARNING: These tires should not be run if cords start to appear in areas other than the tread splice. If you choose to run the tires in this condition, the cords will begin to wear thin and shred, dramatically weakening the tire and creating an extremely unsafe situation.
